Informational Briefing
from the Russian Union of Engineers
15/08/2014

Analysis of the causes of the crash of Flight MH17 (Malaysian Boeing 777)

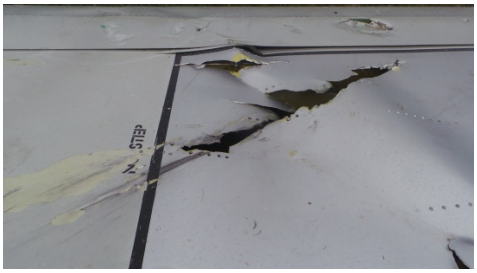
Picture 4. Detail of the Boeing 777 plane

Picture 5. Detail of the Boeing 777's fuselage

Photo 6. Detail of the Boeing 777 cockpit

Of particular note are the holes folded inward in the fuselage. They are round-bored, and usually grouped. Such holes can only be formed by metal objects with a circular cross-section, possibly rods or shells from an aircraft gun. The question arises: who could deliver such projectiles to the aircraft, by what means, and what might they look like?

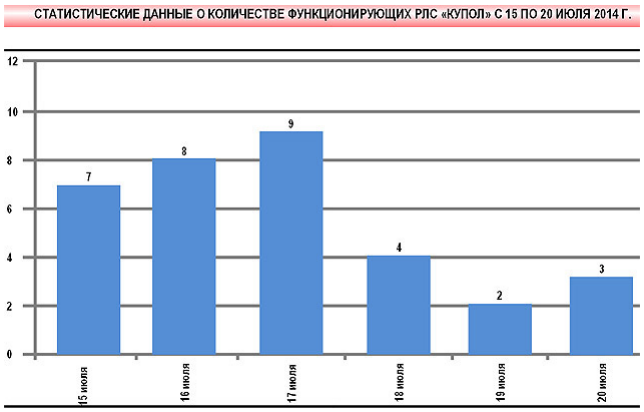
7.1.2. The Russian Defense Ministry said that Russian military radar detected the "Dome" Ukrainian air defense system battery "Buk-M1", working, on the day of the Malaysian Boeing 777 disaster.

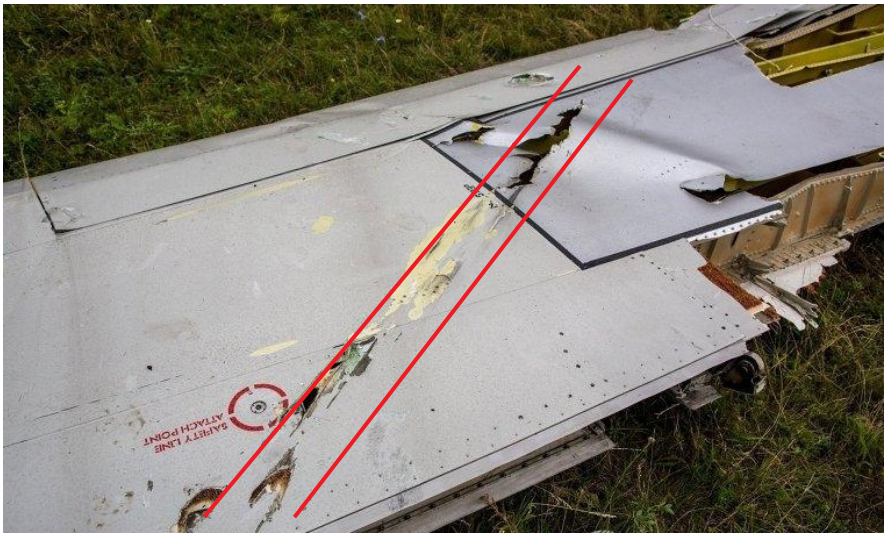
Photo 19. Damage to the flat surfaces of the Boeing 777

It would be logical to assume that the damage shown in photo 19 is more commonly associated with aircraft cannon shells of the GSH or SPPU type.

Damage to the Boeing 777 is not characteristic of the SAM “BUK-M1” missile

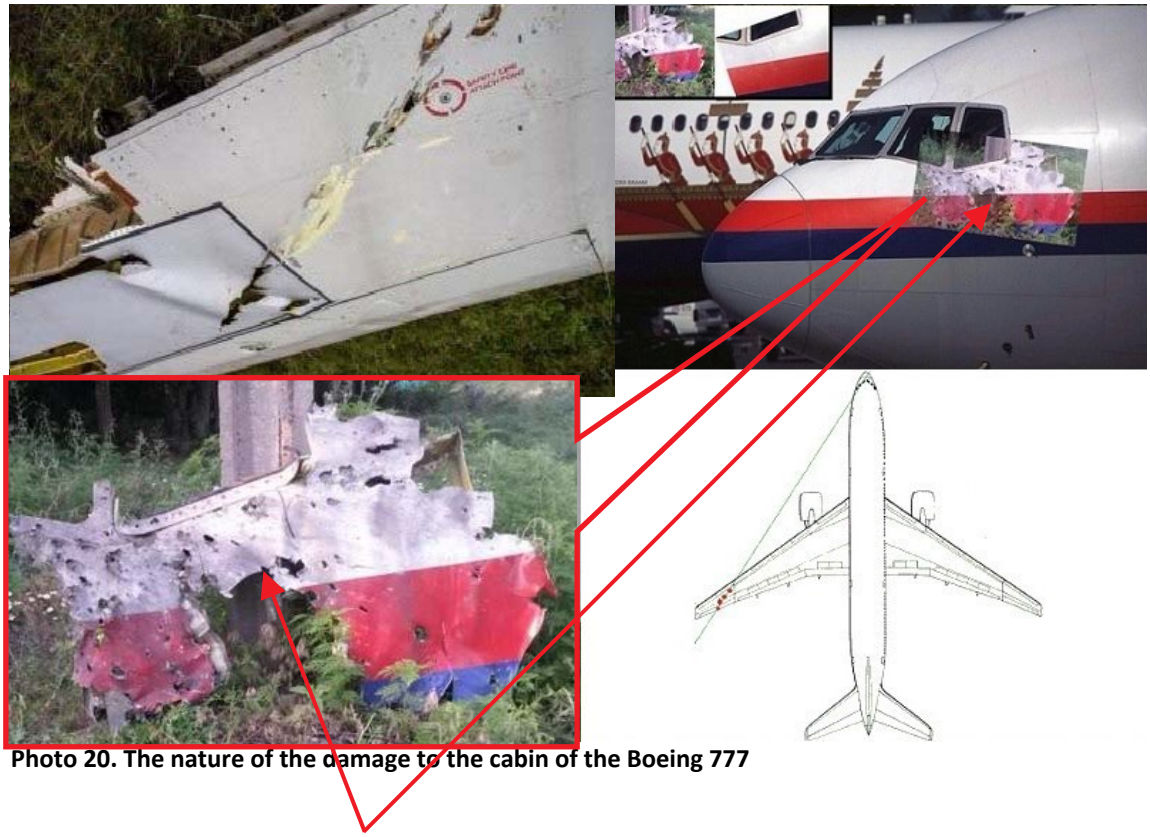
Photo 20. The nature of the damage to the cabin of the Boeing 777

The picture of the entry and exit holes in the cockpit of the Boeing 777 are fully consistent with the passage through the flight of shells from the 20-30 mm caliber guns found on military aircraft. This confirms the second version of what brought down the Boeing. This is further supported by the way the puncture holes are dispersed along the surface of the aircraft. The edges of the fragment of the fuselage from the left side of the cockpit are folded from the inside outward, which indicates that a significant blast occurred within the cockpit as a result of the dynamic impact of the shells on the right side.
On the trim panel the characteristic entry holes are visible as well as some exit points. The edges of the holes are bent inward; they are much smaller and are circular in shape. The exit openings are less clearly formed; their edges are torn outward. In addition, it is clear that exit holes broke through double aluminum lining and tilted it outward. That is, the strike elements ([judging] by type of impact - aircraft cannon shells) punched right through the cockpit. The open rivets were also bent outward.

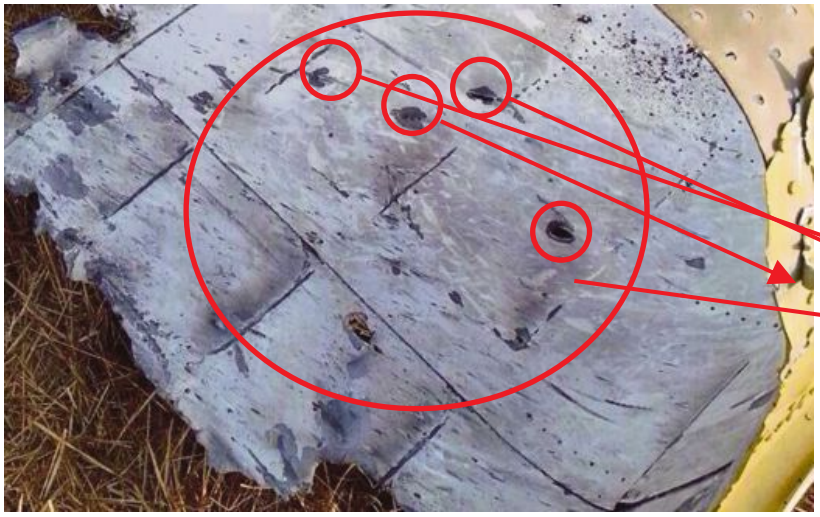
Photo 21. nature of the damage skin Boeing 777

A fragment of the Boeing 777. Clearly seen are the entry holes in the outer layer, folded inward, caused by a 30-мм gun.

The inward folds are clearly seen, which are characteristic of this type of projectile.
